2018 intake manifold Installation Instructions for 2015 Mustang GT.

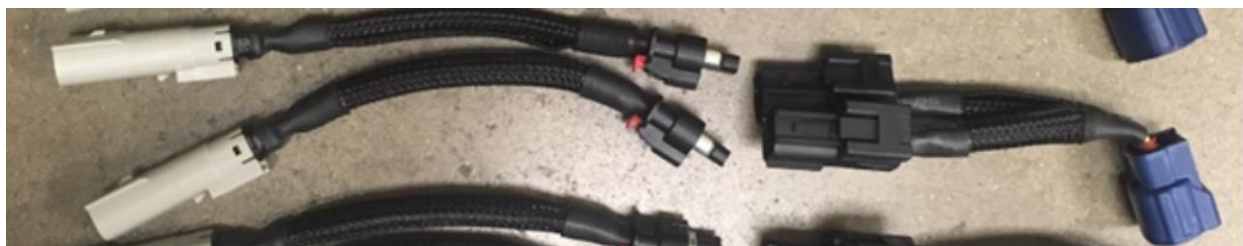
Pictured below is the harnesses provided.

There is one true plug and play set of harnesses we have seen that are available from a member of the mustang6g forum. The link to his contact information is above. Lund Racing has no affiliation with Jason however his harnesses did work for our test vehicle. This will remove some of the stress of cutting the harness on a relatively new car for those not comfortable. If you are not sure of your splicing skills, buy the harness and save yourself a headache.

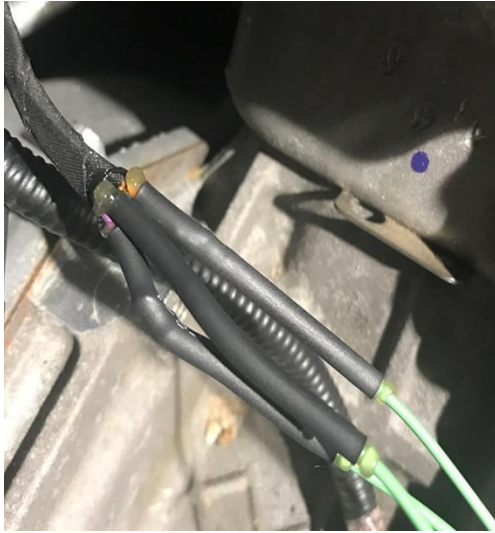
Passenger Side

Cut/Solder/Splice the connections and use the heat shrink provided by ford to protect your connections. Using butt splice connectors is not recommended. Once the connections are made it is advisable to use some wire loom or electrical tape to tidy up the harness and protect the wiring.

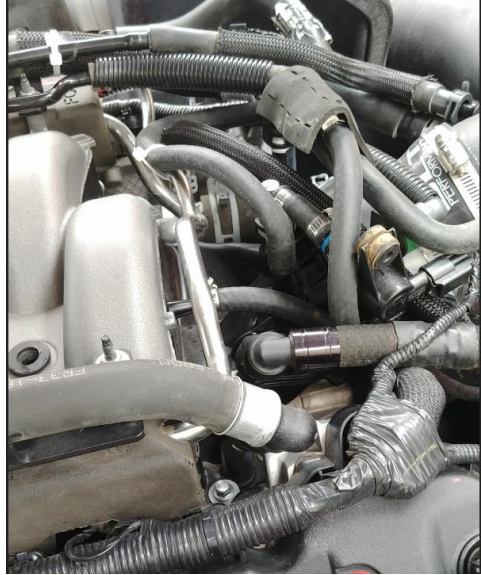
People on the forums seem to be over complicating this part quite a bit, find a place for the EVAP solenoid to sit that the connection will reach. You can trim the bolt holes off as this picture from the forums shows to allow it to fit more snugly. Cap the remaining line that ran to the 2nd solenoid line as well.

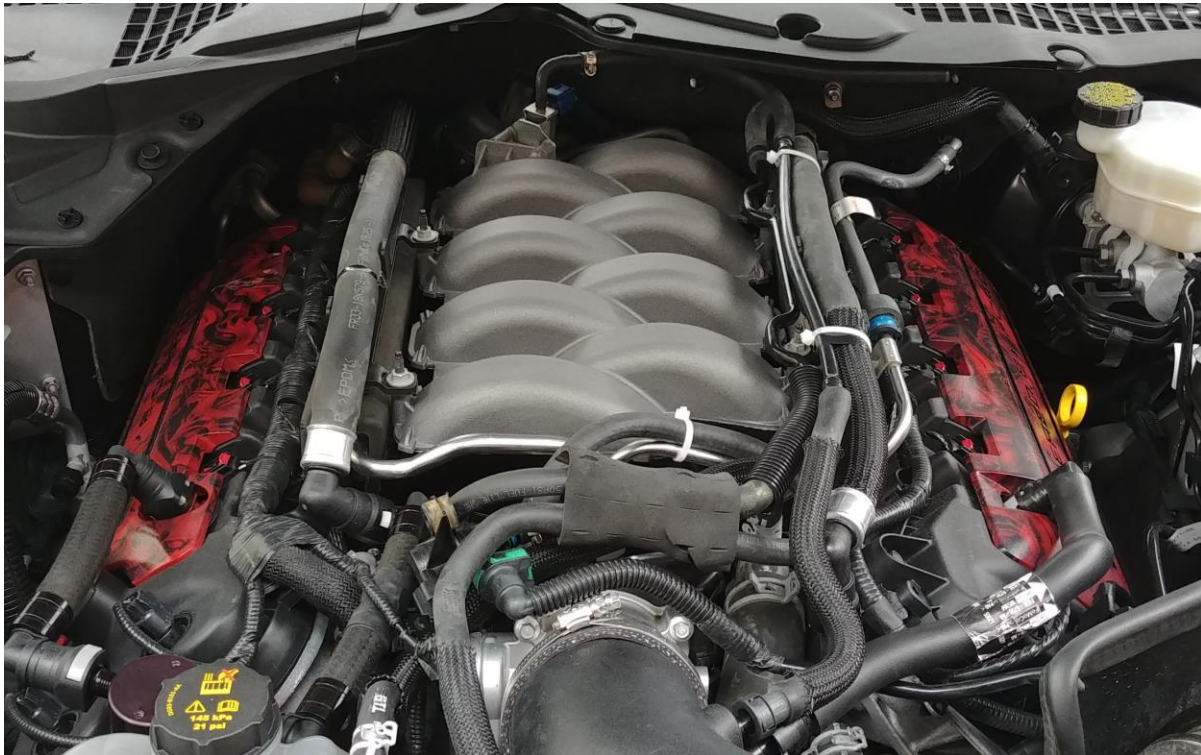
Other than the evap move, everything is quite straight forward, connect the PCV back to your pass side catch can or cover and the lines to your CAI. Here is a larger pic to show the overall routing.
